**PRE-SUBSIDENCE SURVEY
PRIOR TO FULL EXTRACTION AT THE
ZERO NORTH, 4th EAST MAINS, AND 6th WEST PANELS**

CONSOLIDATION COAL COMPANY

Emery Mine
Emery County, Utah

October 2007

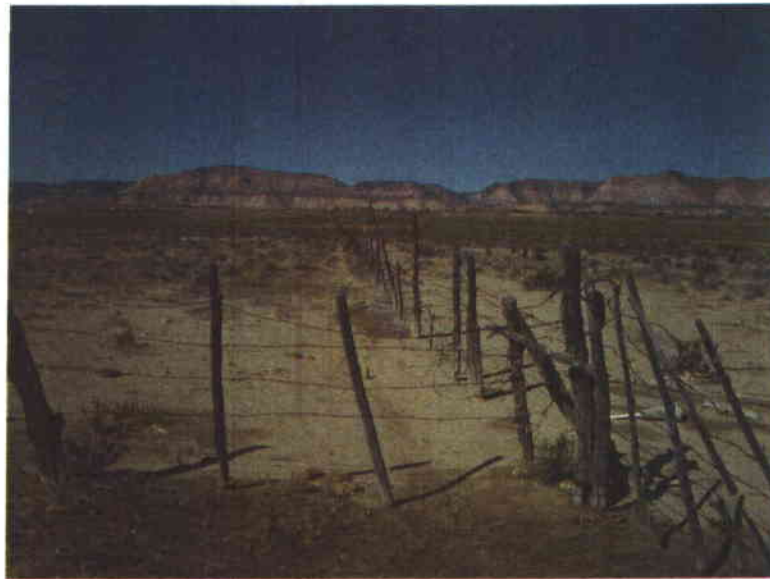
Corners of Sections 22, 23, 26, and 27. Looking west at the ground surface above the Zero North Panel. USGS bench marker is visible where fences intersect. Note that the fence is constructed of unfinished timbers and is in fair condition.

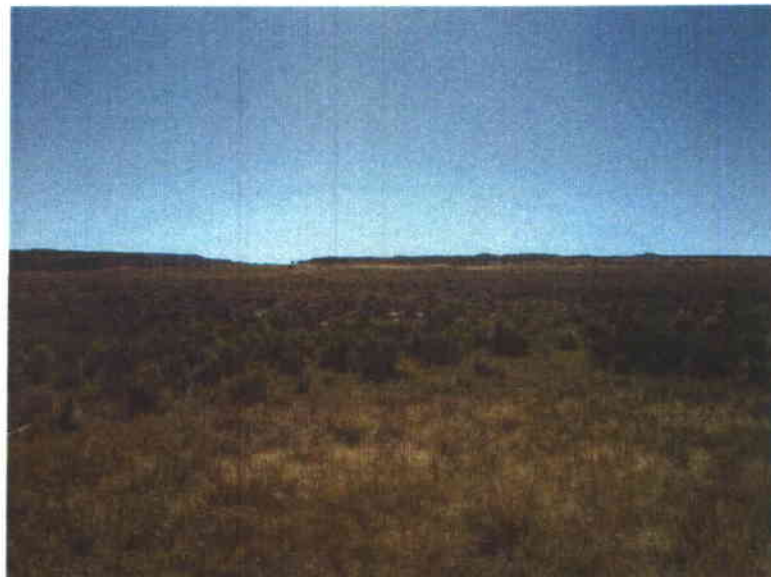
View looking south near the center of the Zero North Panel. The ground surface is relatively

flat, and is not currently used for crop production.

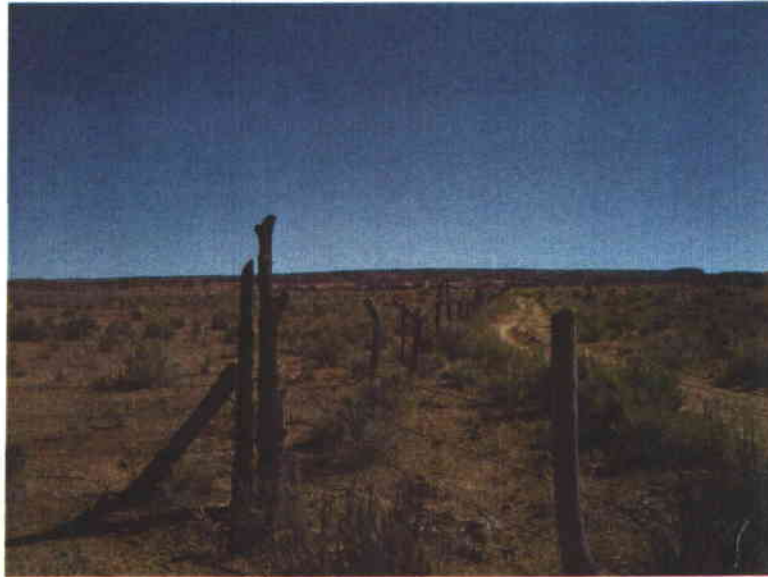
Feature 85. Dirt Road and Fences. This feature is essentially unchanged from how it is described in the Valley Engineering (1980) report, which states the following: “The road is a two-track, single lane, dirt road. The road surface consists of the natural sand and clay that is in the area, and has been compacted by vehicles that travel the road. The fences in the area are barbed wire with either natural rough cut wood posts or steel posts.” The fences are in fair to good condition.

Feature 85. Dirt Road and Fences. Looking east. Fence is constructed from rough cut timbers and is in good condition. The road is an unsurfaced two track road and is in good condition.

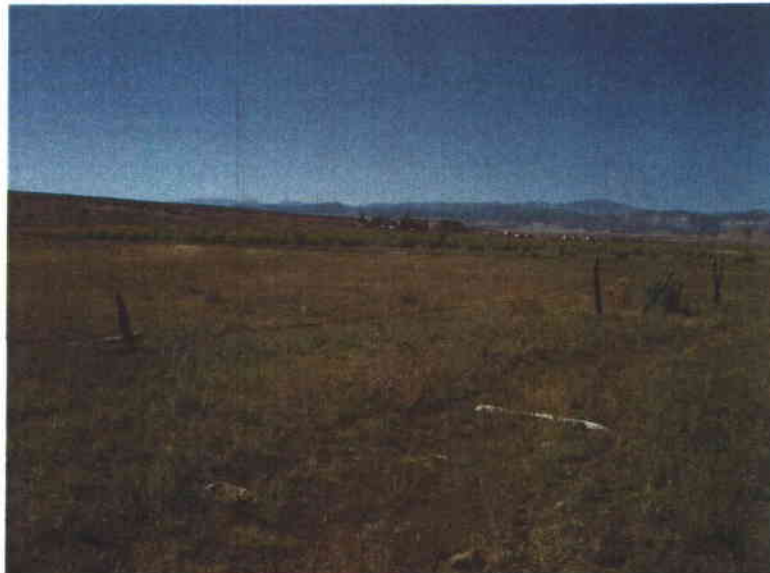
Feature 86. Barbed Wire Fence. This feature has been updated from the Valley Engineering (1980) report. The fence, which is constructed with rough cut timber posts, is in dilapidated condition. Several of the posts are missing, and many of the barbed wire strands are loose and partially buried under the ground surface.

Feature 86. Barbed Wire Fence. Looking west at the fence that extends to the north from the point labeled Feature 86 on Appendix V-5 Figure 1. The fence is missing several of its rough cut timber posts, and is in poor condition.

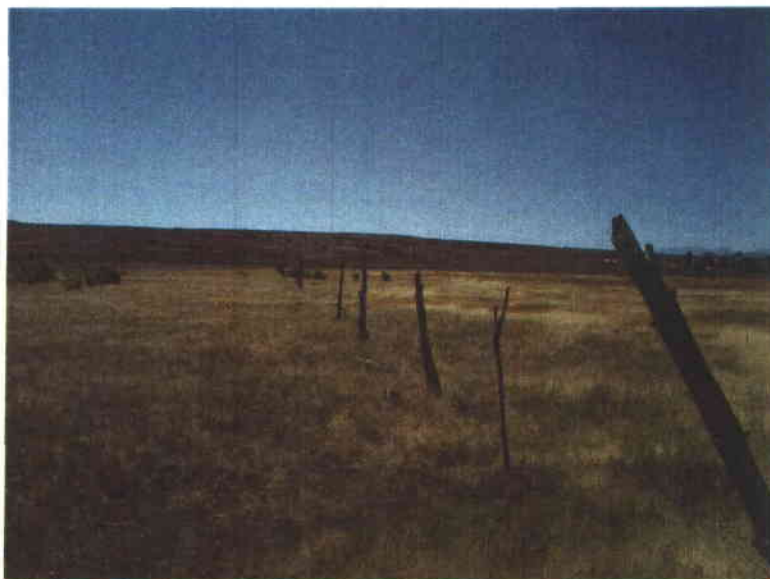
Feature 86. Barbed Wire Fence. Looking south along the fence that extends to the north from the point labeled Feature 86 on Appendix V-5 Figure 1.

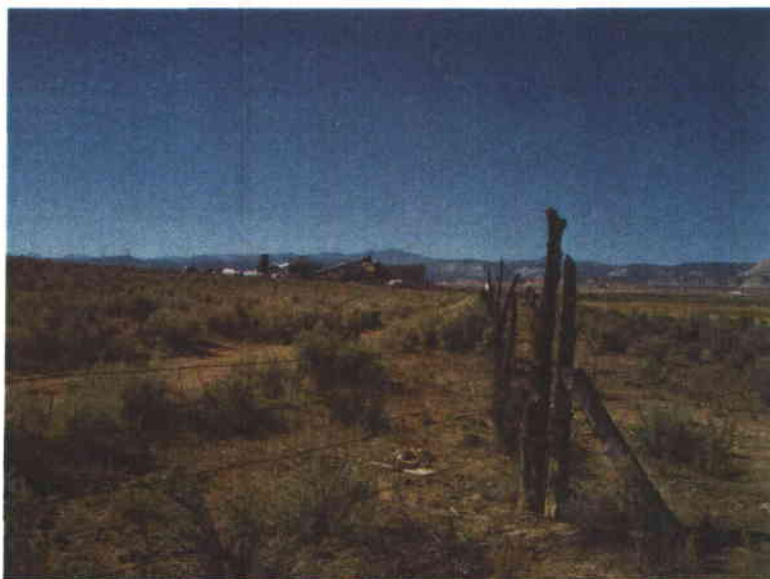
Feature 87. Small Creek and Fence. The description of this feature has been updated from the Valley Engineering (1980) report. The fence is constructed of rough cut timber posts and barbed wire and is in good condition. The “small creek” was incorrectly identified in the 1980 survey. The survey area is relatively flat, dry, and contains no established stream channels. The 1980 survey shows several irrigation ditches overlying the Zero North Panel which drain toward this “stream channel,” which was actually an irrigation outflow ditch. During the 2007 survey, it was evident that many of the irrigation ditches had been allowed to fill in, including the “stream channel” identified in the 1980 survey.

Features 86, 87. Barbed Wire Fence, Small Creek and Fence. Looking southwest. Fence is constructed from rough cut timbers and is in good condition. The small creek identified in the 1980 survey was not present in 2007.

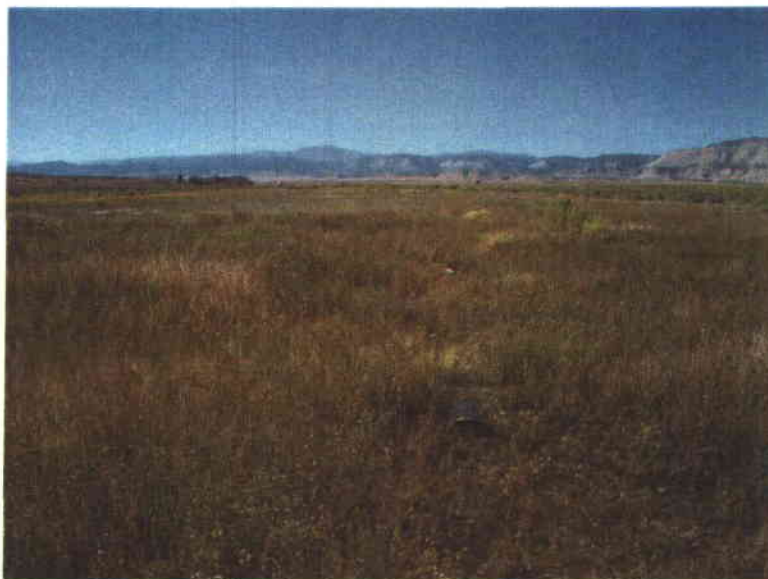
Remnant irrigation ditch in northern portion of Zero North Panel. Note the partially buried piping in the foreground. This was the only irrigation ditch that was identified in 2007, and it is in dilapidated condition.

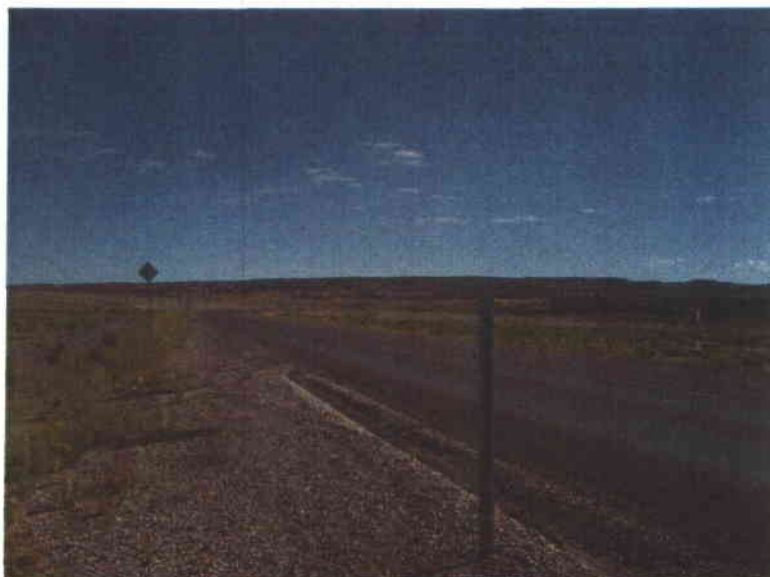
Paved Access Road to 4th East Portal. Looking southeast along road. The 4th East Portal is visible in the distance.

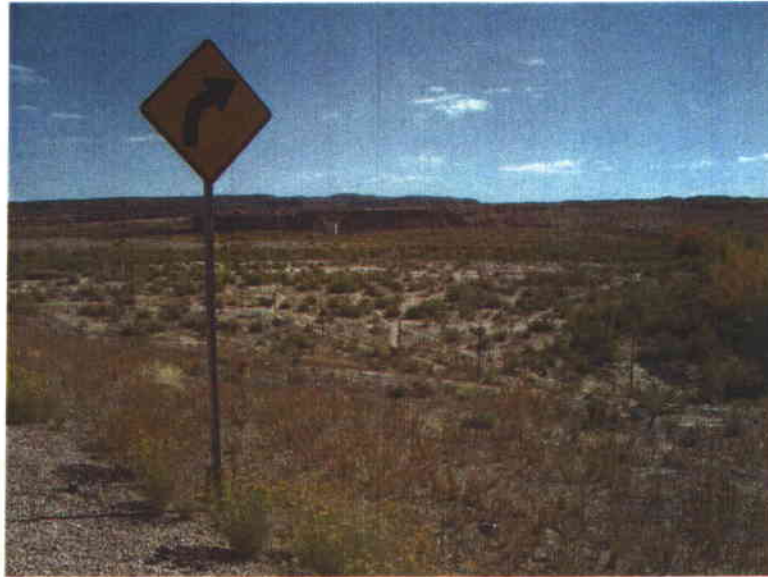
4th East Mains South of Paved Access Road. Looking South. Note Christiansen Wash on far right of photo. The land surface is undeveloped.

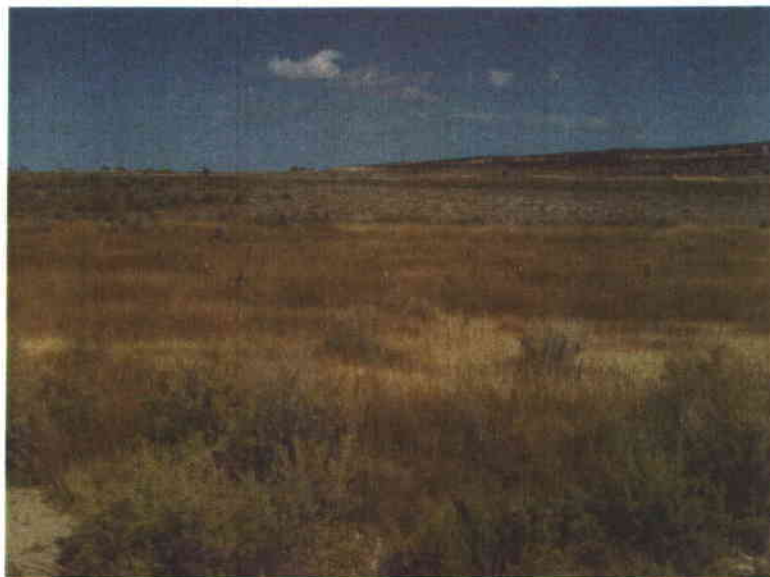
Feature 88. Small Fenced Area. The description of this feature has been updated from the Valley Engineering (1980) report. It has fallen into disrepair since it was surveyed in 1980. The fenced area measures approximately 25 feet by 25 feet. Many of the fence posts are no longer straight, and the barbed wire sags. The area in the vicinity of the fence is overgrown with vegetation.

Feature 88. Small Fenced Area. Looking east.

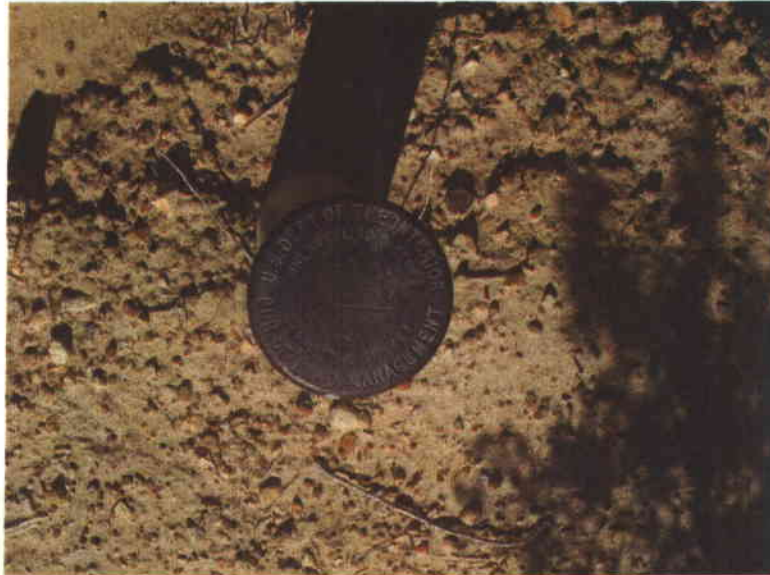
Feature 89. Quarter Section Marker. This feature remains the same as described in the Valley Engineering (1980) report, which states the following: "This quarter section corner marker is in Range 6 East Township 22 South. It divides sections 22 and 27. The marker is a metal cap on a short steel pipe."

Feature 89. Quarter Section Corner Marker.

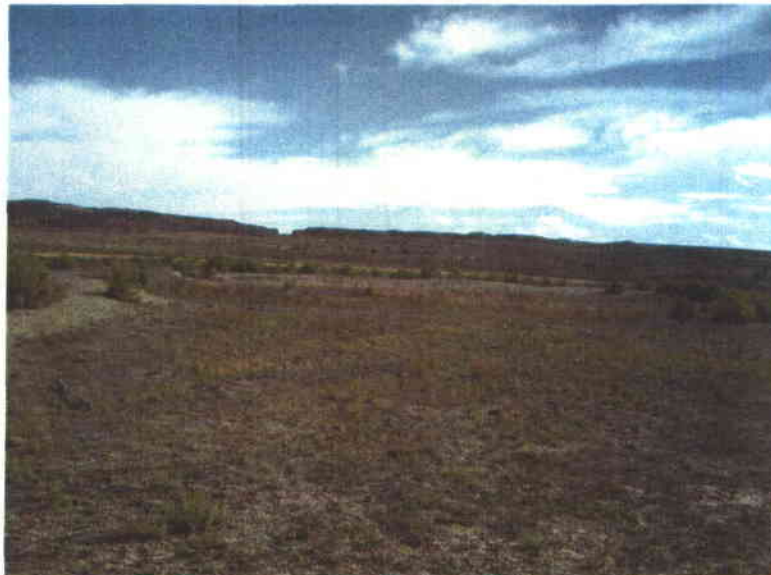
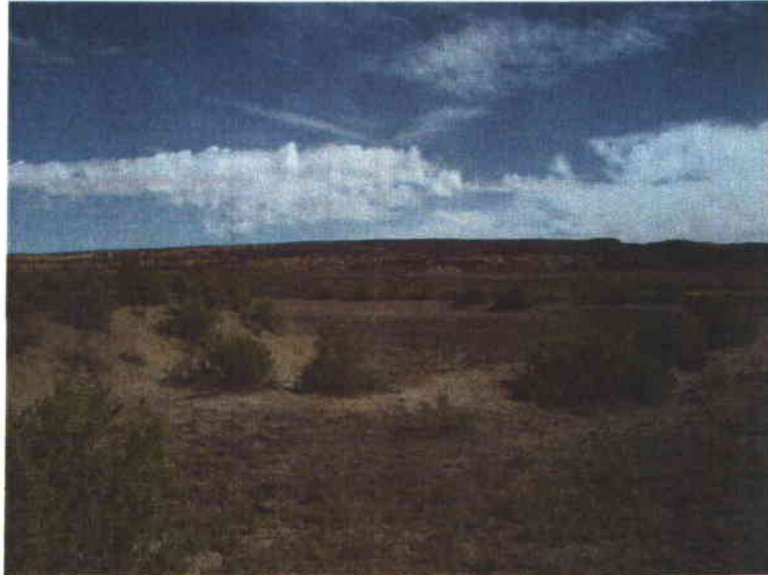
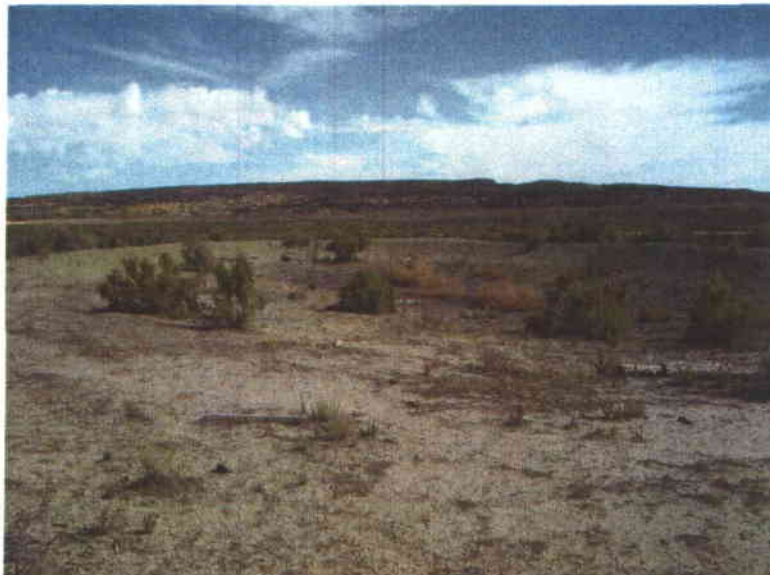
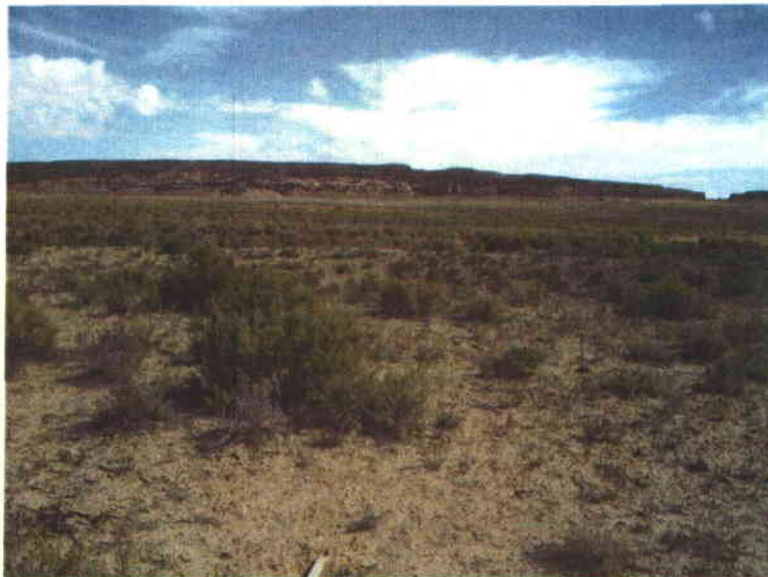
Feature 90. Ponds. The description of this feature has been updated from the Valley Engineering (1980) report. The ponds were empty during the October 2007 survey, but four earth berms were present that appeared capable of impounding water. The berms are approximately 3 feet tall. Three of the berms are clustered together in a north to south alignment, and one berm is located a few hundred feet to the northeast. A dry irrigation ditch located west of the three clustered ponds appears to serve as a water source. A dilapidated wooden corral and small shed is located just north of the three clustered ponds.

Feature 90. Ponds. Looking southeast at southern pond.

Feature 90. Ponds. Looking southeast at central pond.

Feature 90. Ponds. Looking southeast at northern pond.

Feature 90. Ponds. Looking southeast at northeastern pond.

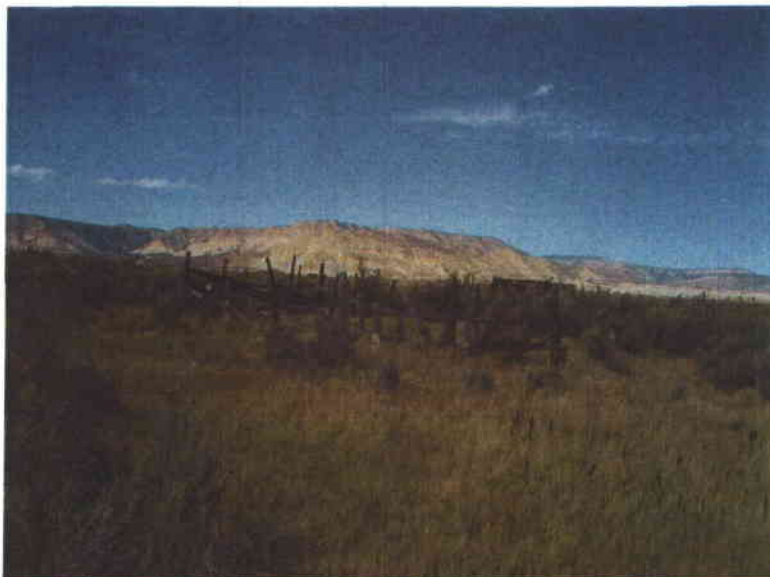
Feature 90. Ponds. Looking north at a nearby dilapidated corral and small Shed.

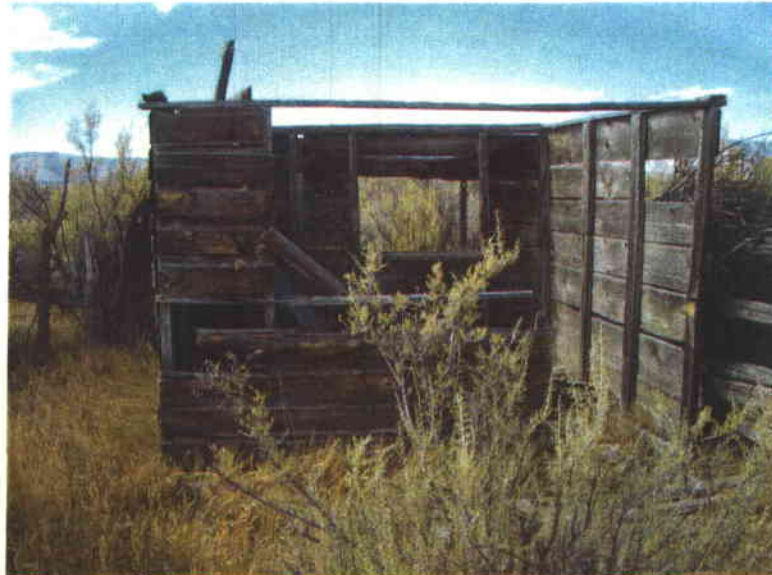
Feature 90. Ponds. Looking west at a nearby small Shed.

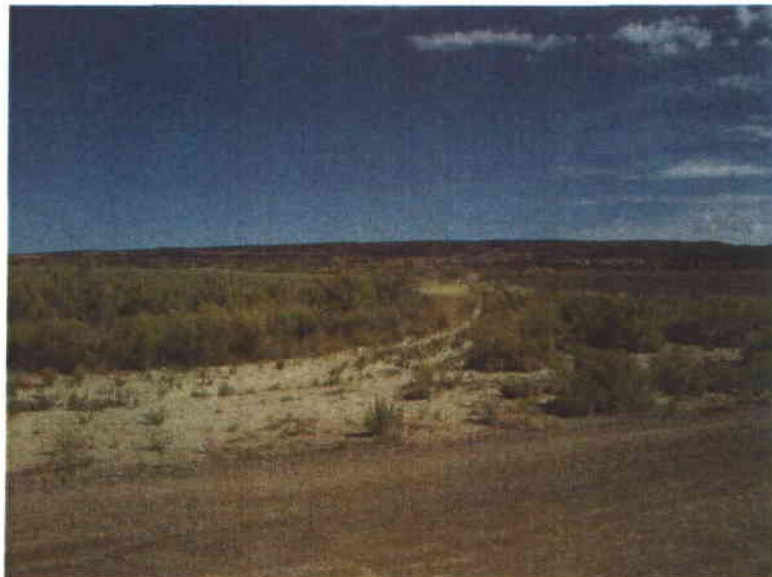
Feature 92. Fence and Dirt Road. The description of this feature has been updated from the Valley Engineering (1980) report. This feature is in fair to poor condition. The road is rutted and overgrown with vegetation, especially where irrigation runoff discharges from the center of the field located to the north. The fence, which is constructed from rough cut timber and barbed wire, is also overgrown by grasses. Many of the fence posts are no longer plumb, and many of the barbed wire strands sag.

Feature 92. Fence and Dirt Road. Looking east. Note that road and fence are overgrown and in fair to poor condition.

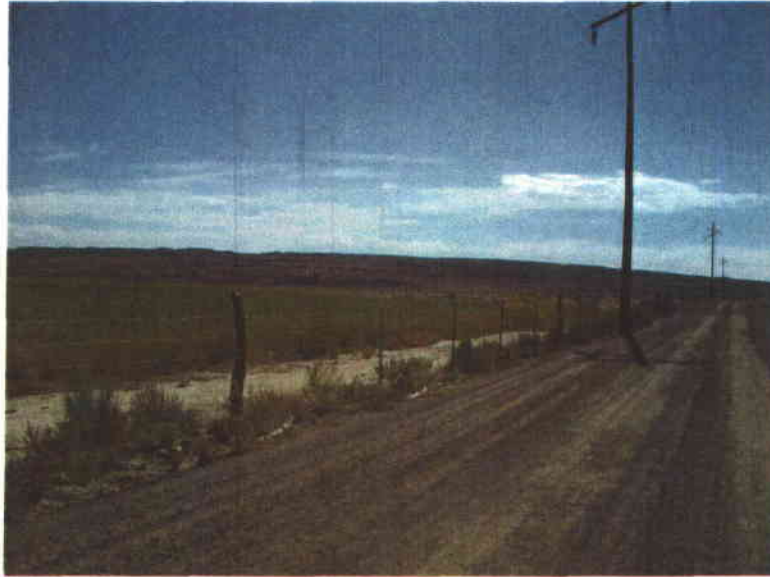
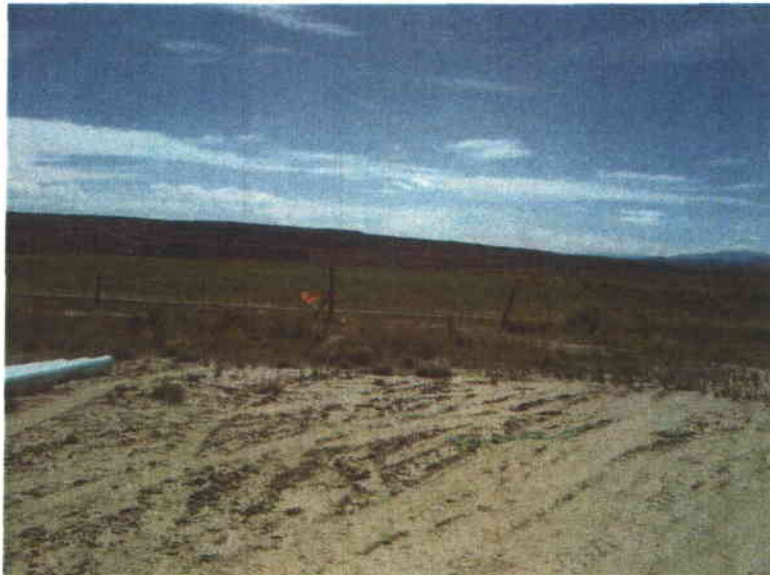
6th West Panel (it does not exist above the 4th East Mains) contains two irrigated fields with a total of 9.1 acres of cultivated land. The northwestern field drains to the south/southeast and receives irrigation water from a ditch running along its eastern edge. The southeastern field drains to the south and receives irrigation water from a ditch that enters the field from the north.

Feature 93. Irrigation Ditches and Farmland. Looking south at the northern field.

Feature 93. Irrigation Ditches and Farmland. Looking south at the southern field.

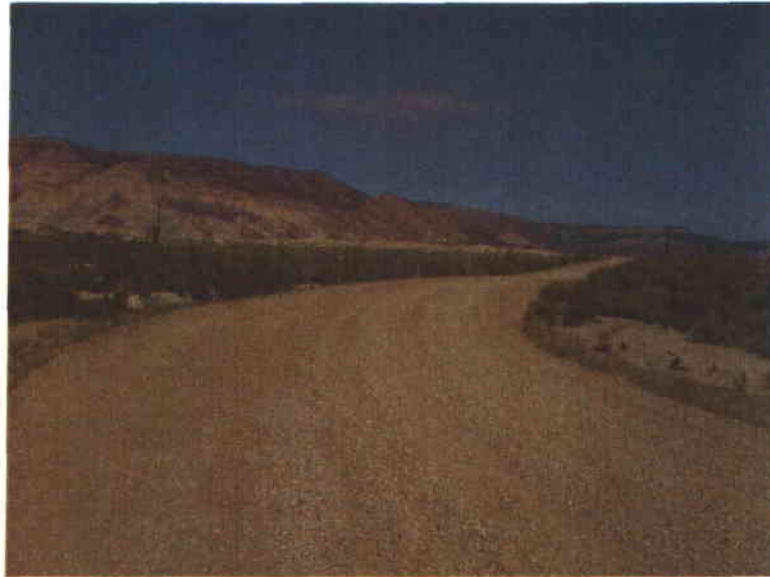
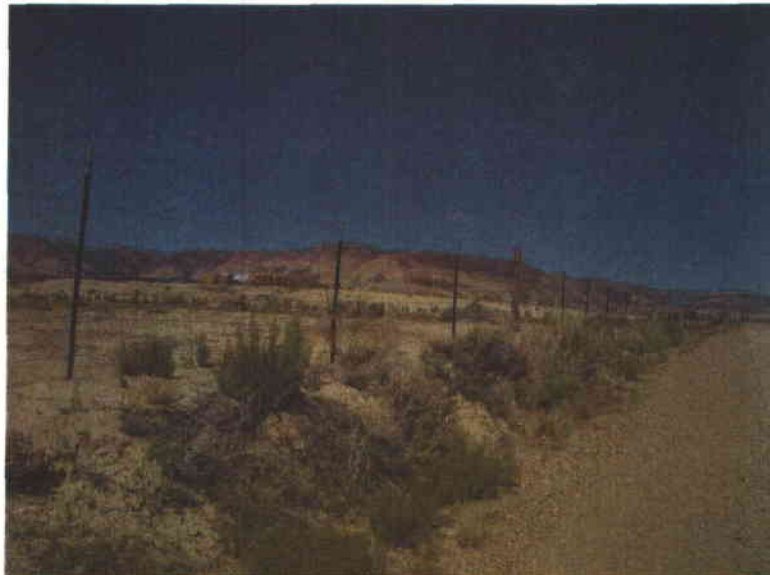
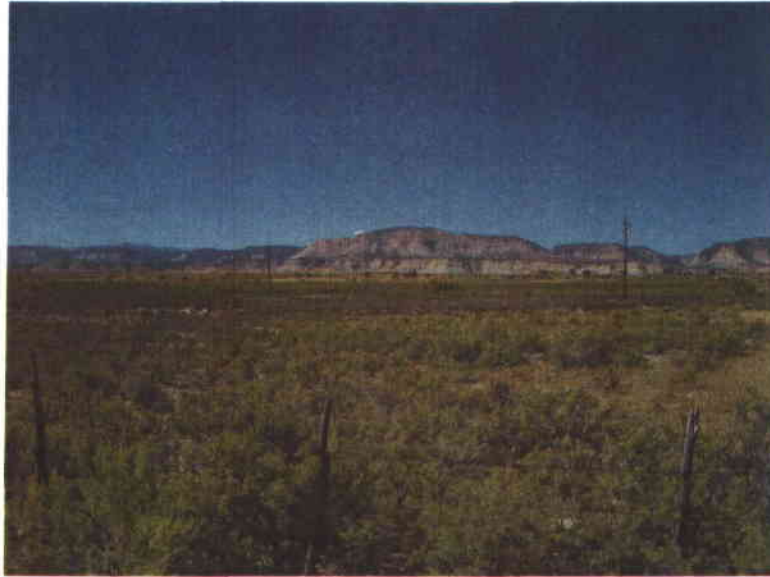
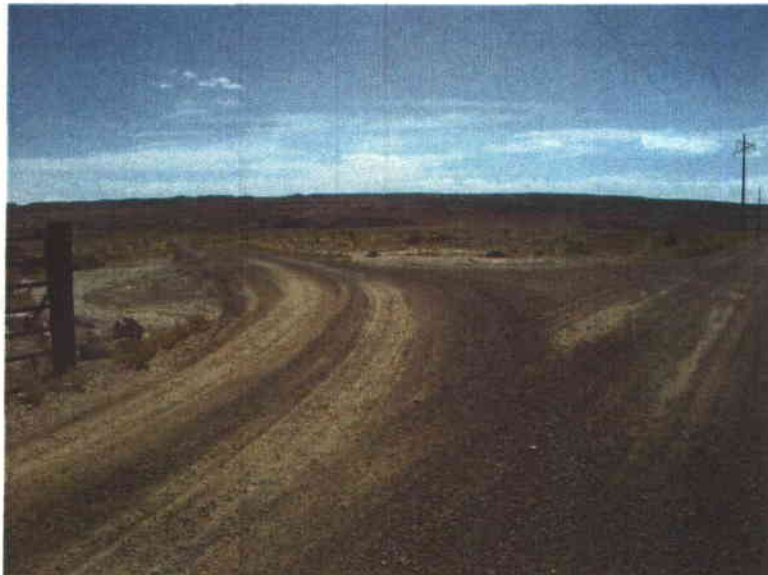
Feature 97. Dirt Road, Utility Power Line, and Fence. The description of this feature has been updated from the Valley Engineering (1980) report. The dirt road is approximately 24 feet wide with a surface constructed from imported, compacted gravel. The road is in very good condition. The utility power line hangs from 30 to 40 foot tall wooden poles, and is in very good condition. The poles appear relatively plumb. The barbed wire fence is located on the west side of the road and has posts constructed from rough cut timbers and metal tee-stakes. The fence is in good to excellent condition.

Feature 97. Dirt Road, Utility Power Line, and Fence. Looking north from a point just north of where the dirt road crosses Christiansen Wash.

Feature 97. Dirt Road, Utility Power Line, and Fence. Looking north. Note that Feature 103 is visible in the distance.

Feature 97. Dirt Road, Utility Power Line, and Fence. Looking west at fence and power line.

Feature 97. Dirt Road, Utility Power Line, and Fence. Looking south from road junction in Panel 6W. The 4th East Portal is visible in the distance.

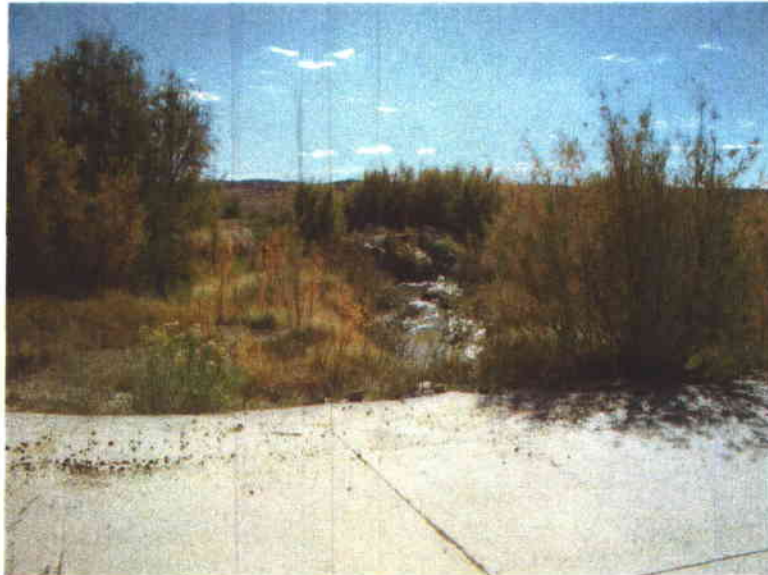
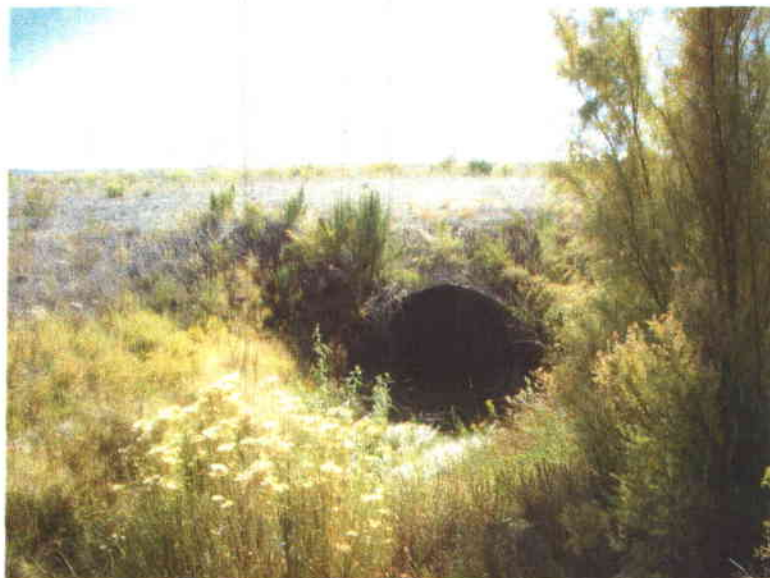
Feature 98. Small Creek. The description of this feature has been updated from the Valley Engineering (1980) report. The creek is called Christiansen Wash. During the October 2007 survey, flow in the creekbed was approximately 3 feet wide. The creek flows to the southwest and discharges into Quitcupah Creek. The creek flows under the paved access road for the 4th East Portal via a 60-inch diameter coated corrugated steel pipe that is in very good condition.

Feature 98. Small Creek. Looking south from where the creek intersects the graded gravel road. Note the embankment for the paved access road for the 4th East Portal along the horizon. This small creek is called Christiansen Wash. During the October 2007 survey, the stream was flowing about 3 feet across.

Feature 98. Small Creek. Looking south at the 60-inch diameter coated corrugated metal pipe that conveys Christiansen Wash under the paved access road for the 4th East Portal.

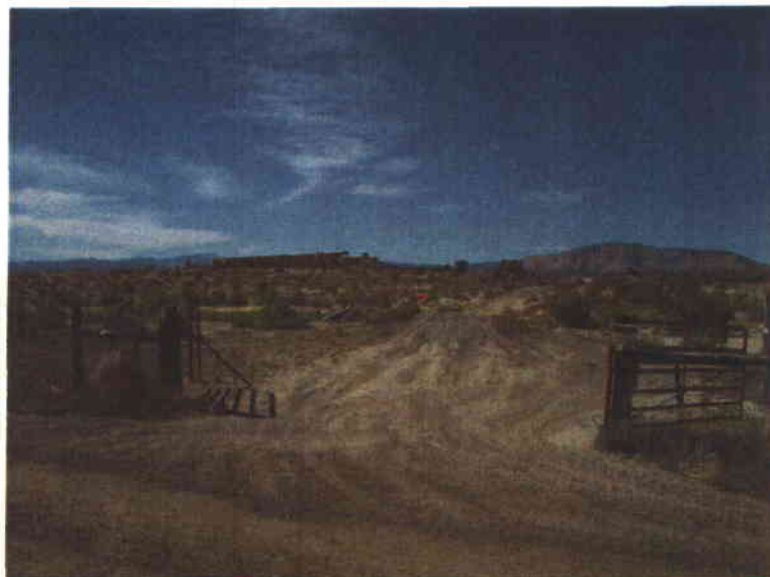
Feature 103. Farm Land, Corrals, Ponds, and Fences. The description of this feature has been updated from the Valley Engineering (1980) report. Most of this feature lies just outside the boundaries of the 4th East Mains and 6th West Panel. However, a fenced and gated hay storage area is located just to the northwest of the 6th West Panel. The fence and gate are in good

condition. An unimproved dirt road (good condition) leads from the gravel road up to the hay storage area.

Feature 103. Farm Land, Corrals, Ponds, and Fences. Looking west at a hay storage area.
